**TRANSPORTATION SCIENCES
CRASH DATA RESEARCH CENTER**

**CALSPAN ON-SITE AIR BAG RELATED CHILD FATALITY INVESTIGATION
CALSPAN CASE NO. CA96-010
VEHICLE - 1996 DODGE CARAVAN SE
LOCATION - TENNESSEE
CRASH DATE - 1996**

1. Report No. CA96-010	2. Government Accession No.	3. Recipient's Catalog No.	
4. Title and Subtitle Calspan On-Site Air Bag Related Child Fatality Investigation Vehicle - 1996 Dodge Caravan SE Location - State of Tennessee		5. Report Date: --

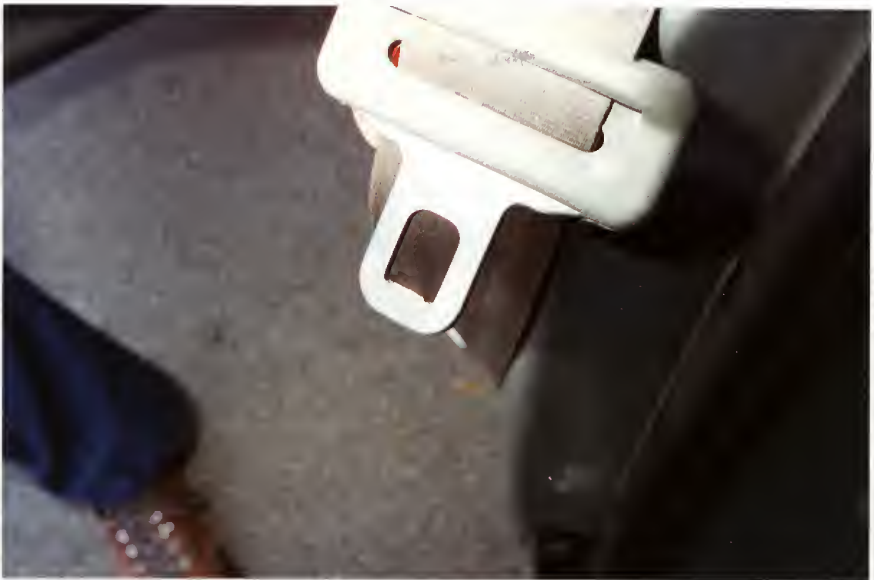
58. View of the left front seat belt's latch plate.

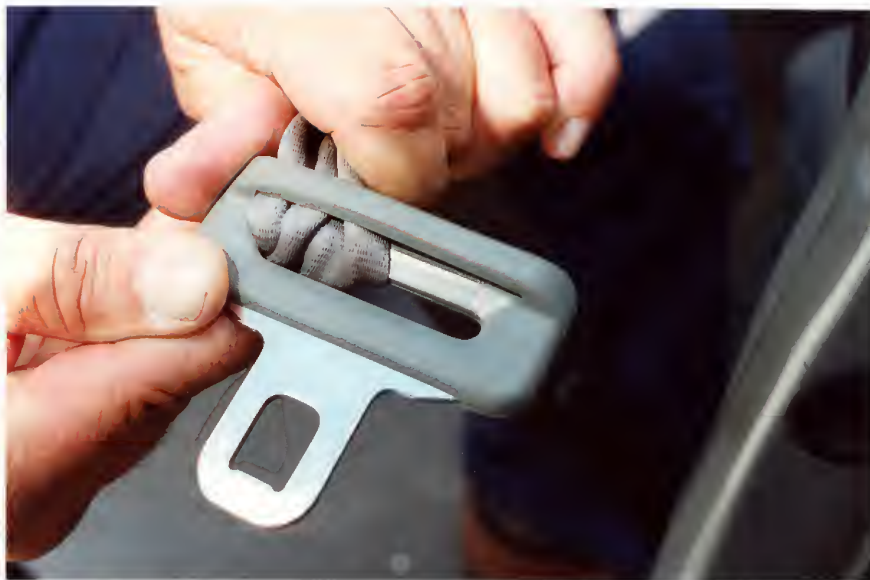
The 1996 Dodge Caravan was equipped with manual 3-point lap and shoulder belts in the six outboard seated positions. The front seat belt systems consisted of a continuous loop lap and shoulder belt webbings with locking latchplates. Emergency locking retractors were mounted in the base of each B-pillar. The belt systems utilized an adjustable upper anchorage (D-ring). The driver's D-ring was found adjusted to a point that was 2.0 cm (0.8 in) below the full up position, or 7.6 cm (3.0 in) above the bottom adjustment point, yielding a total of 9.6 cm (3.8 in) of vertical adjustment. The driver was wearing the manual 3-point shoulder belt. Routine usage marks present on the latchplate. There was no loading evidence on the driver's seat belt webbing, however, the latchplate crossbar exhibited a 1.3 cm (0.5 in) abrasion to the polymer coating at the forward aspect of the crossbar (refer to Photograph No. 59).

59. View of an abraded area on the plastic covering the latch plate.

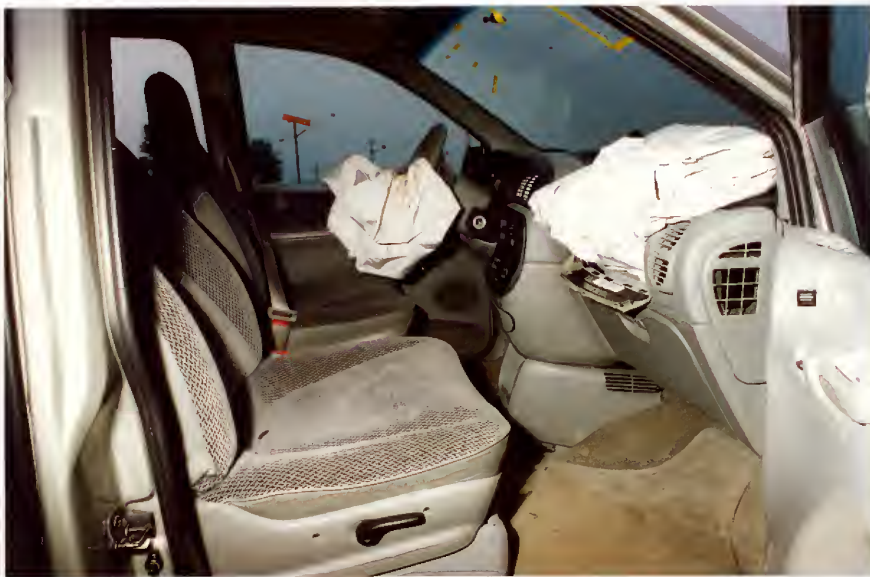
60. Right side view of the forward occupant compartment.

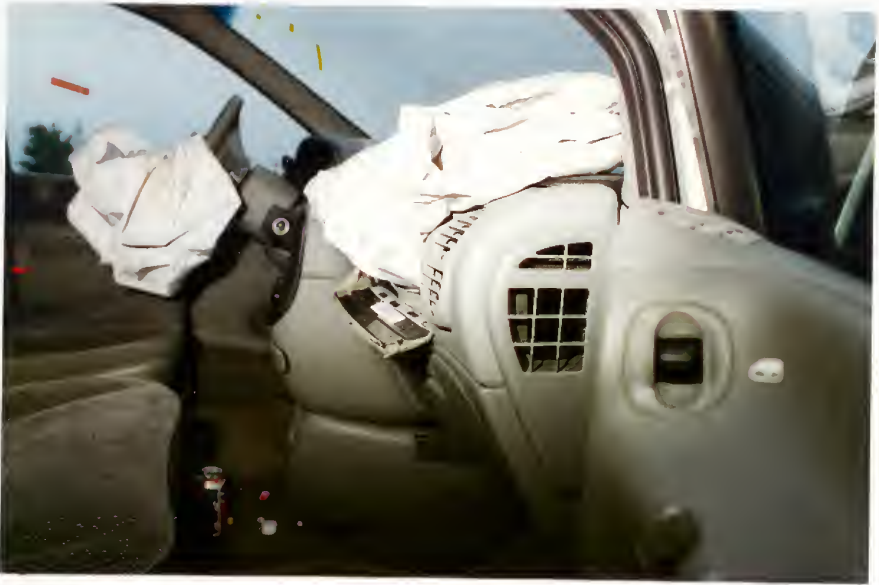
61. Right perpendicular view of the instrument panel.

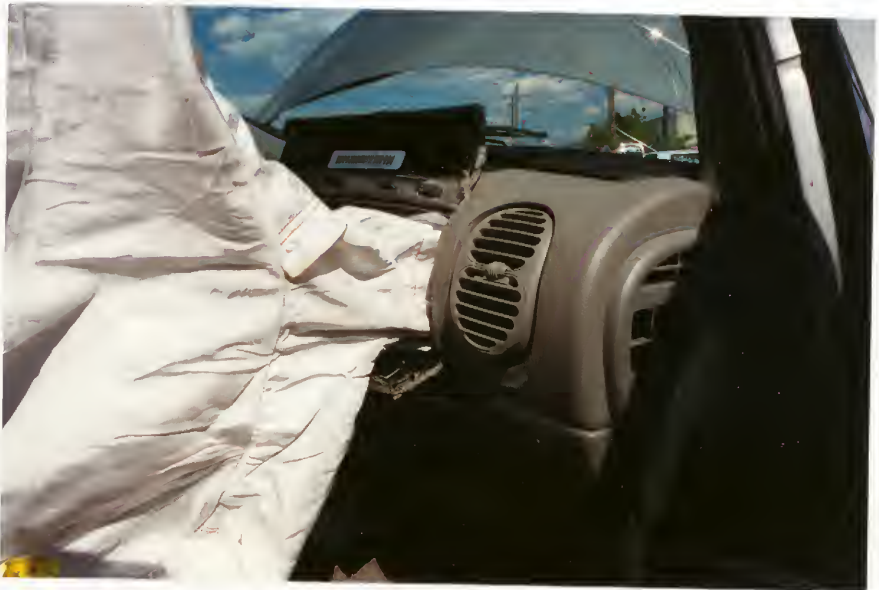
62. Overall view of the mid-mount passenger side air bag module.

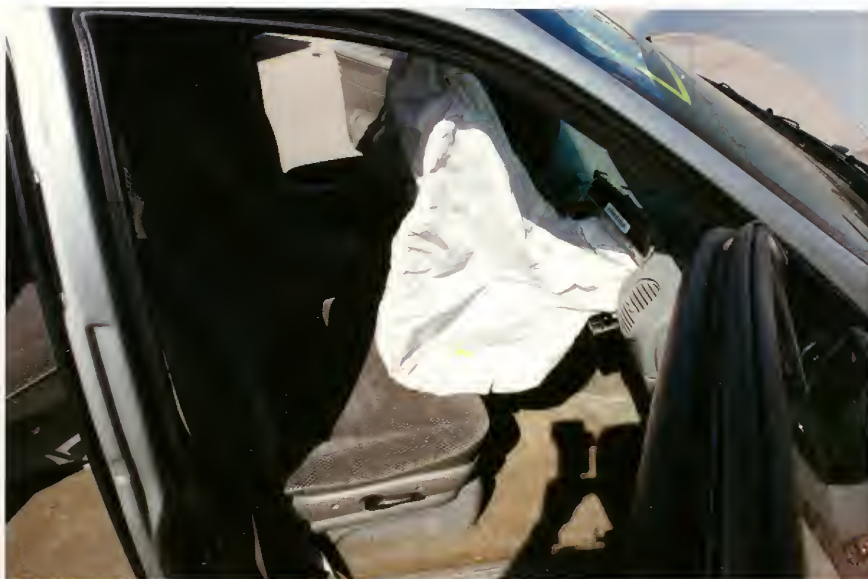
63. Overall right side view of the air bag in simulated deployment.

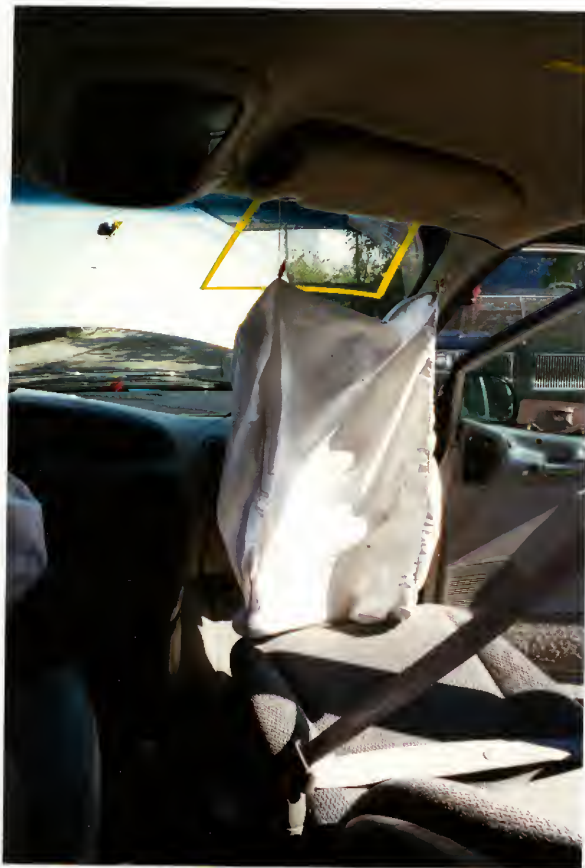
64. Overall front view of the passenger side air bag.

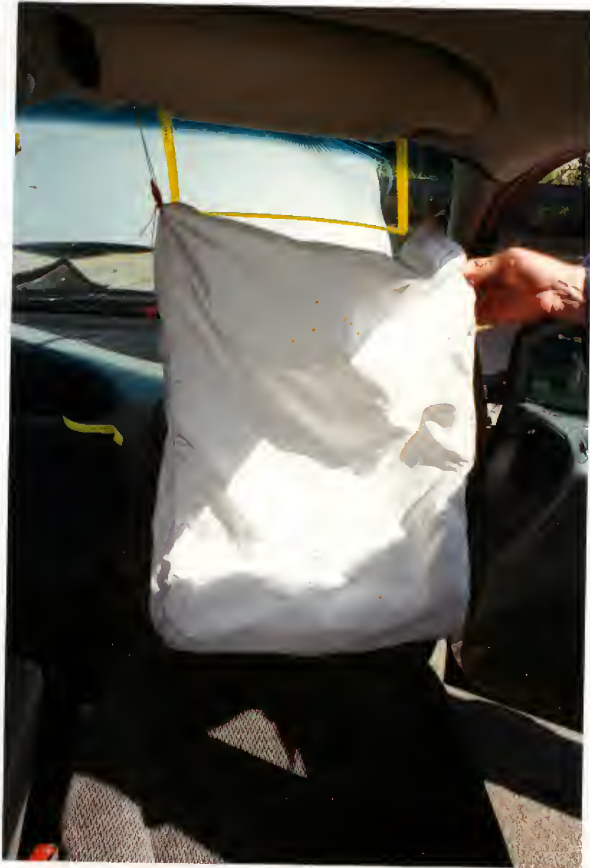
69. Overall view of the face of the passenger side air bag.

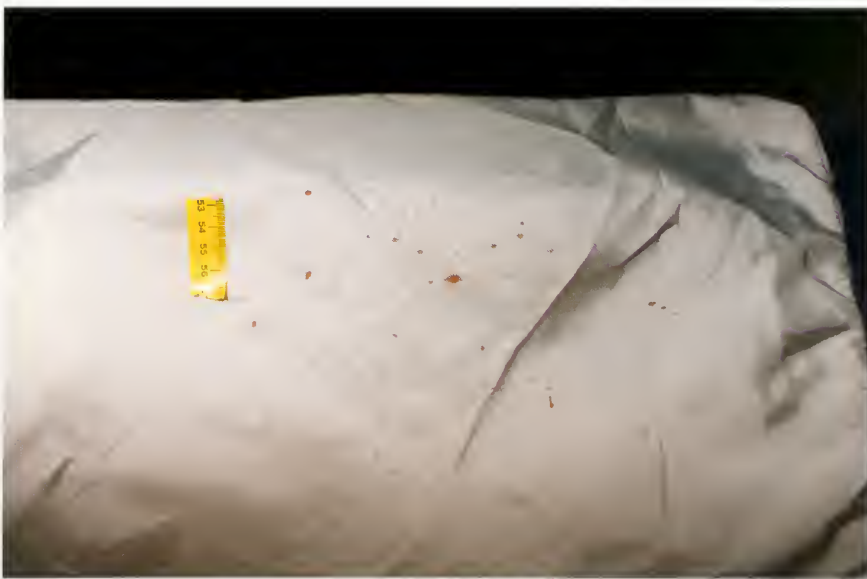
8.0 in) down from the top of the bag (refer to Photograph No. 70). The second blood spatter was noted 30.5-38.1 cm (12.0-15.0 in) below the top of the bag and 0.0-5.1 cm (0.0-2.0 in) inboard of the right side of the bag (refer to Photograph No. 73). A third blood spatter was located 54.6-58.4 cm (21.5-23.0 in) below the top of the bag and 14.0-21.6 cm (5.5-8.5 in) inboard of the right side (refer to Photograph No. 72). A probable body fluid/material (tissue or nasal expulsion) transfer of 12.7 cm (5.0 in) in length was located on the right side of the passenger side air bag, centered between the side seams and 7.6 cm (3.0 in) above the lower seam. Gray vinyl transfers were present at the bottom right sector of the bag 13.3-5.1 cm (5.15-2.0 in) up from the bottom seam and 7.0-17.8 cm (2.75-7.0 in) left of the right seam (refer to Photograph No. 74-75). These resulted from bag expansion within the module assembly.

71. Close-up view of the blood spatters at the 12 o'clock position.

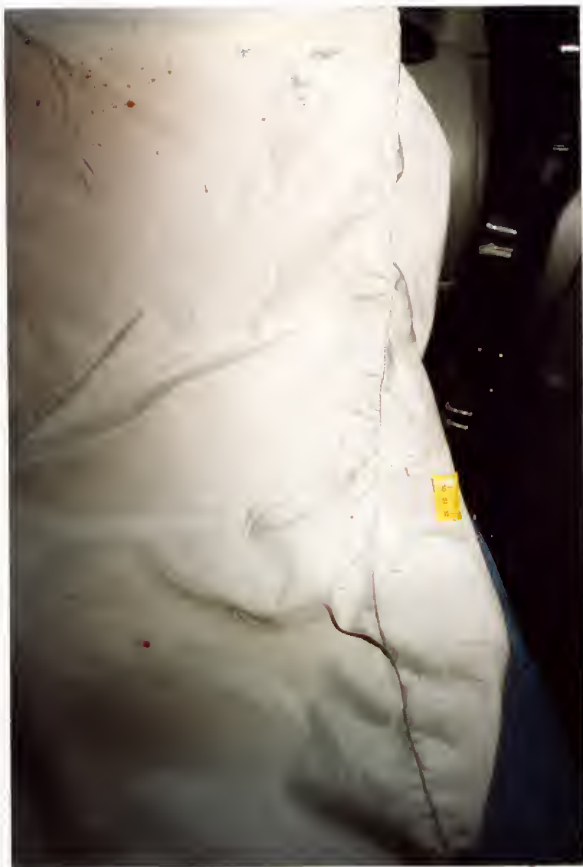
72. View of the blood spatters on the center and right side of the passenger air bag.

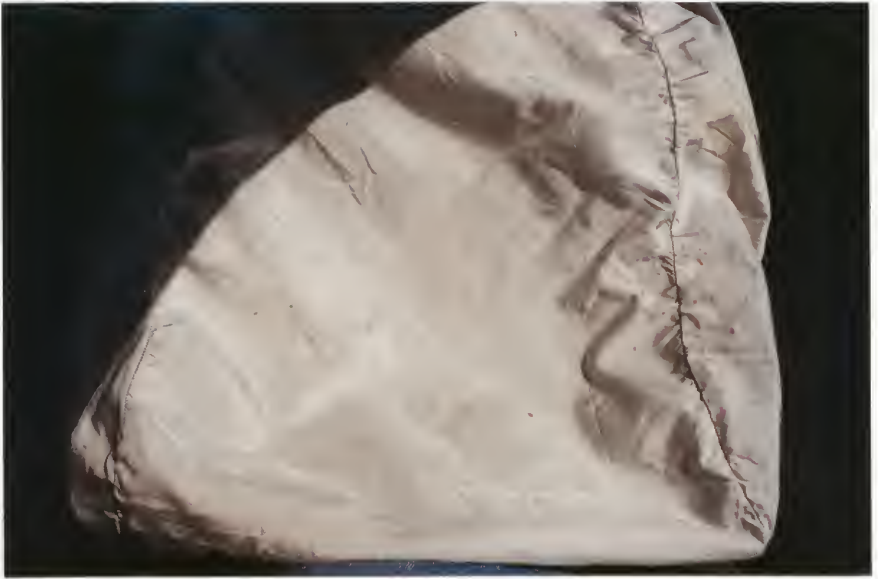
73. View of the lower portion of the face of the passenger air bag.

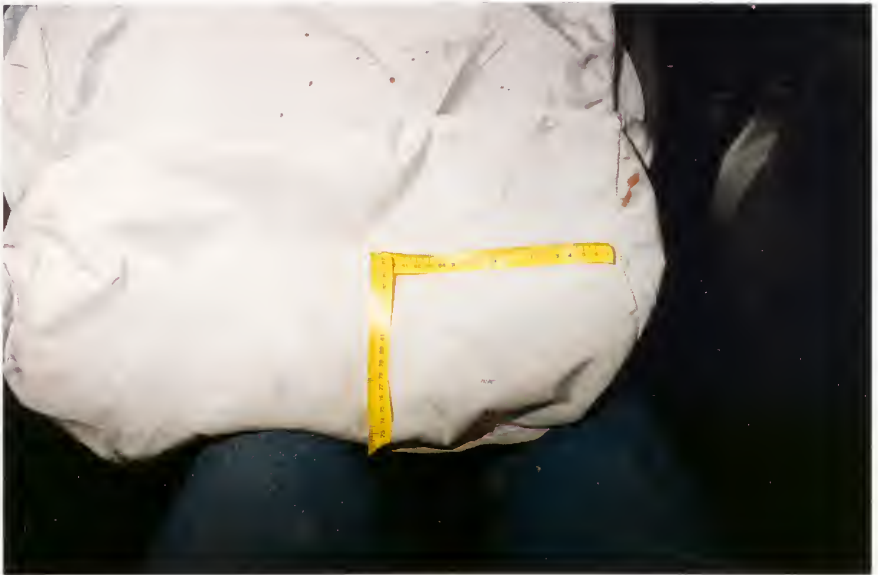
74. View of a gray vinyl transfer on the lower left quadrant of the air bag.

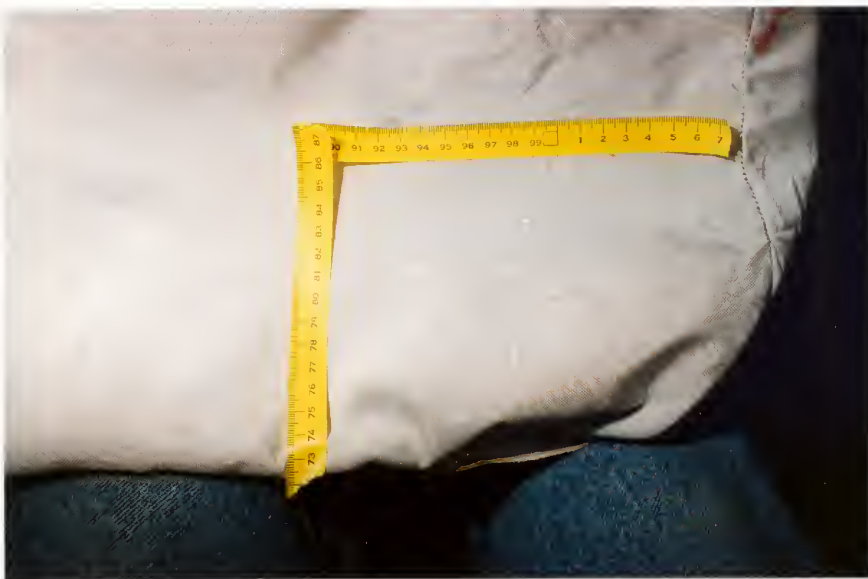
75. Close-up view of the vinyl transfers.

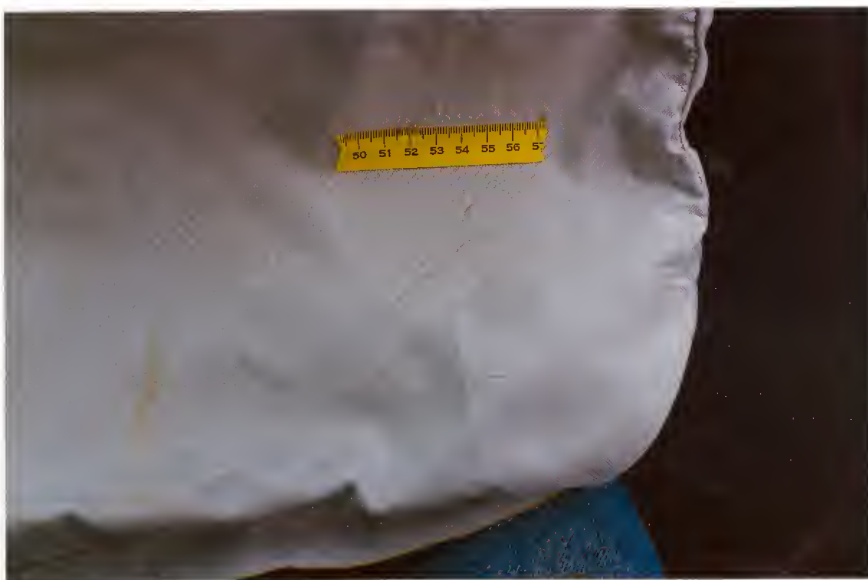
76. Close-up view of the vinyl transfers.

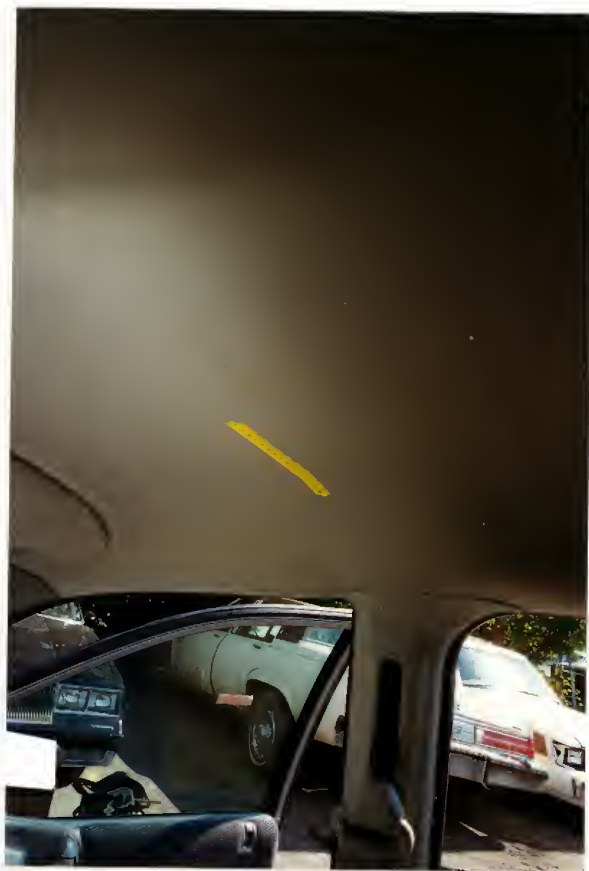
77. View of the headliner above the right front occupant's seat.

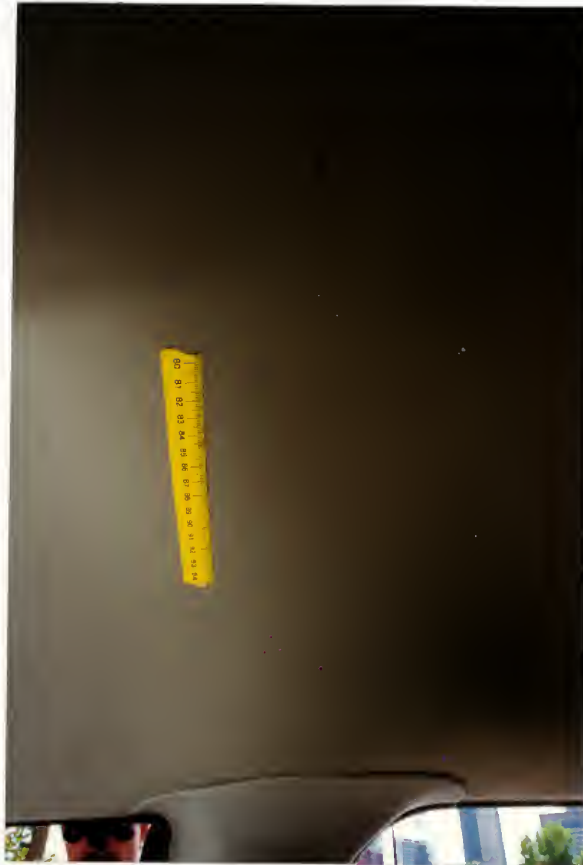
78. Close-up view of the blood spatters on the headliner.

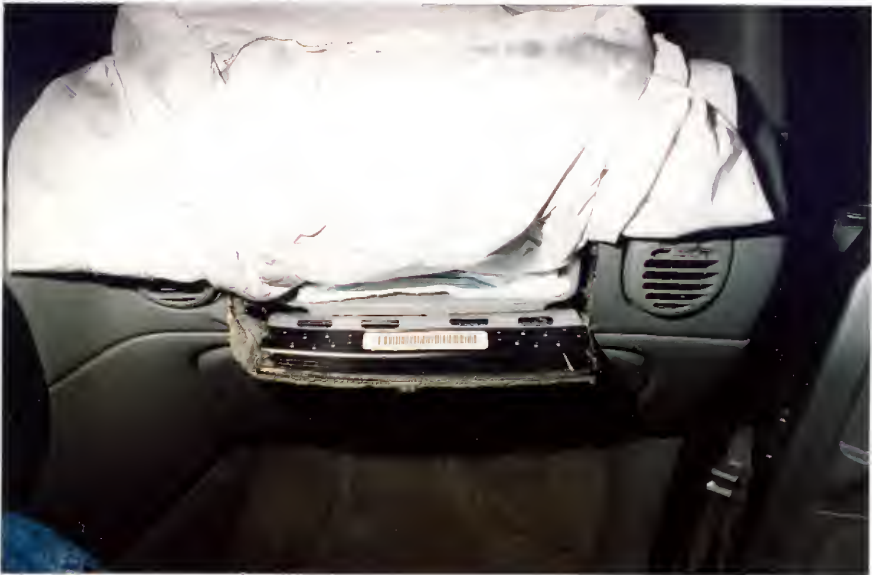
80. View of the lower passenger side air bag module cover flap.

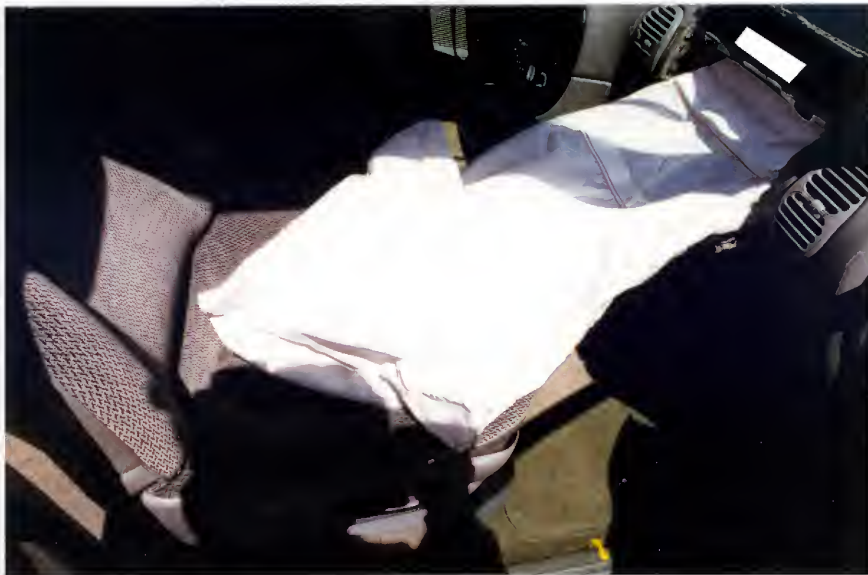
81. Right view of the extended passenger side air bag.

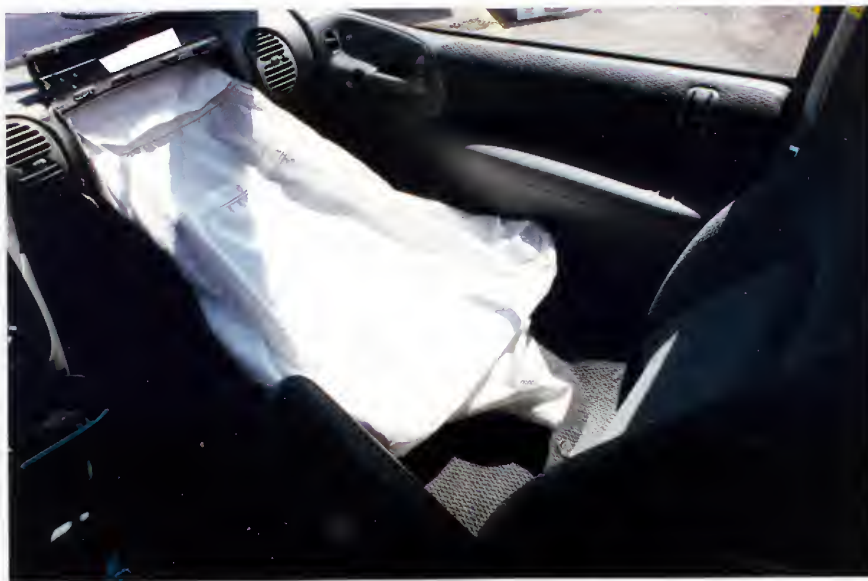
82. View of the rearward extension of the passenger side air bag.

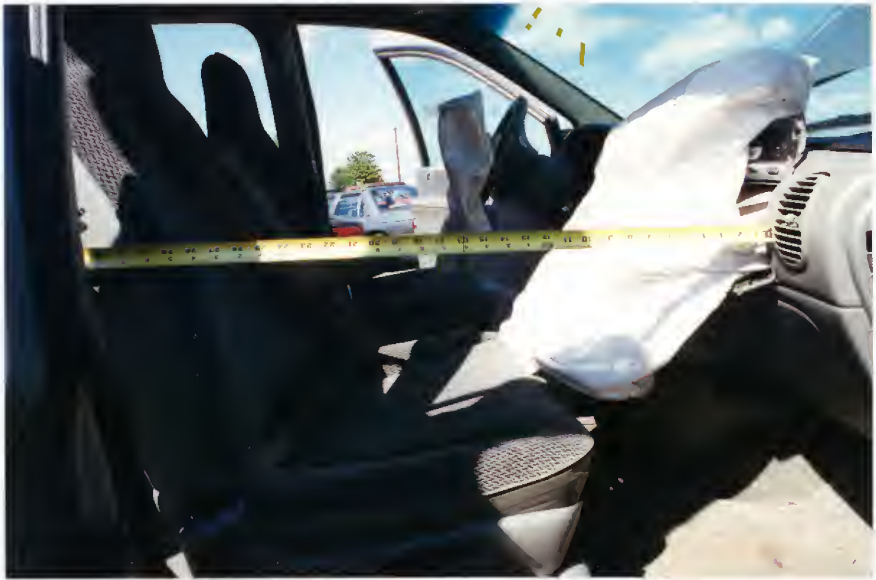
83. Longitudinal measurement of the position of the seat relative to the instrument panel.

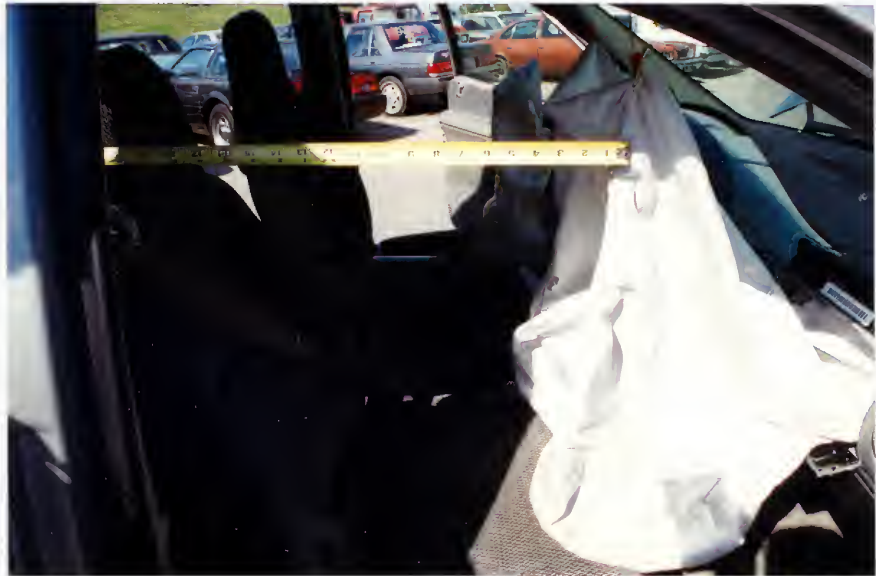
84. Longitudinal measurement of the seat relative to the deployed passenger side air bag.

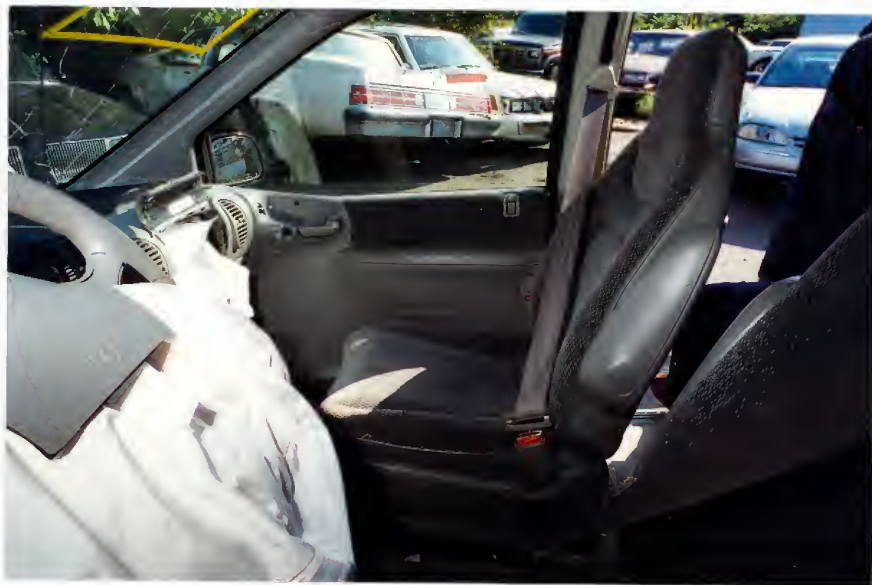
85. View of the right front seat location.

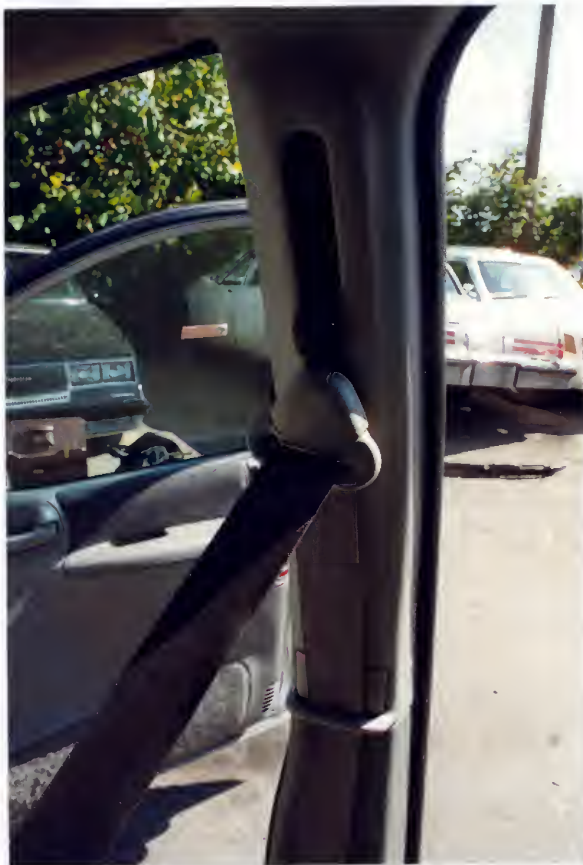
86. View of the right front D-ring location.

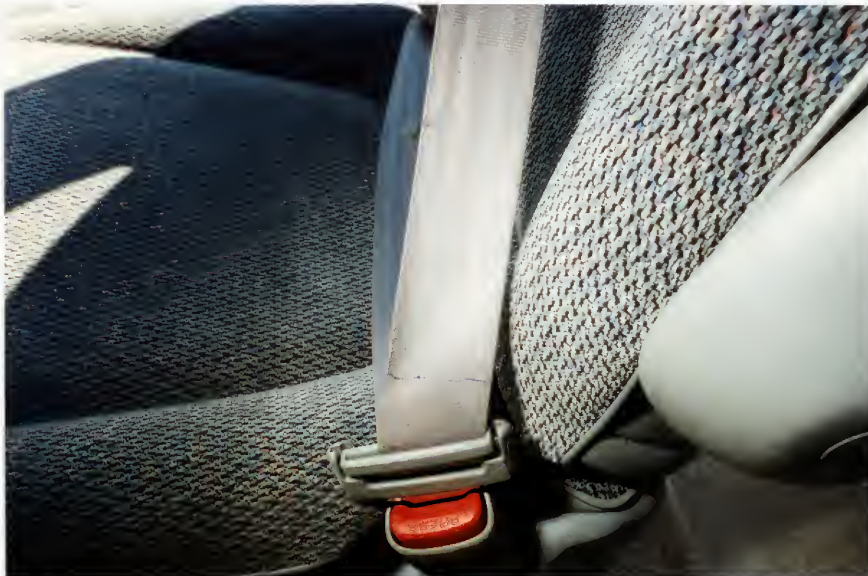
87. View of blood spatters on the right front restraint webbing.

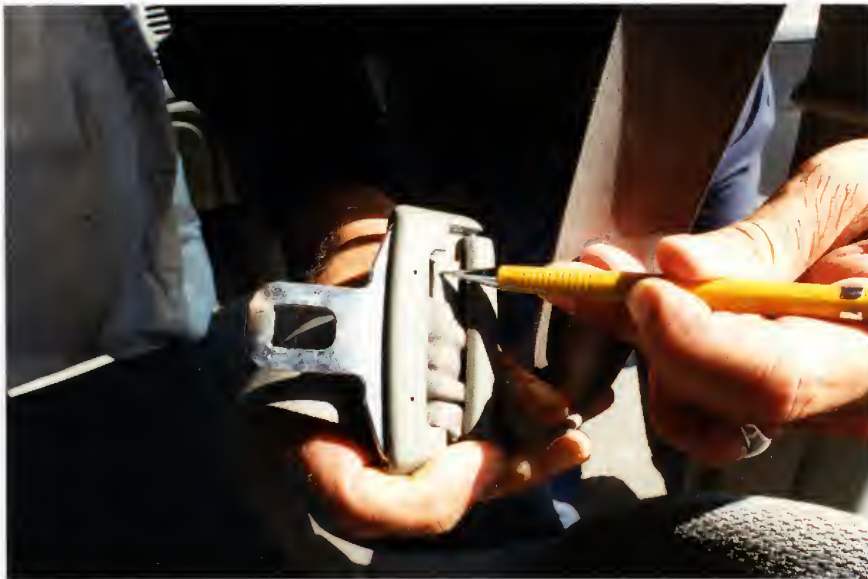
88. View of the abraded plastic on the right front latch plate.

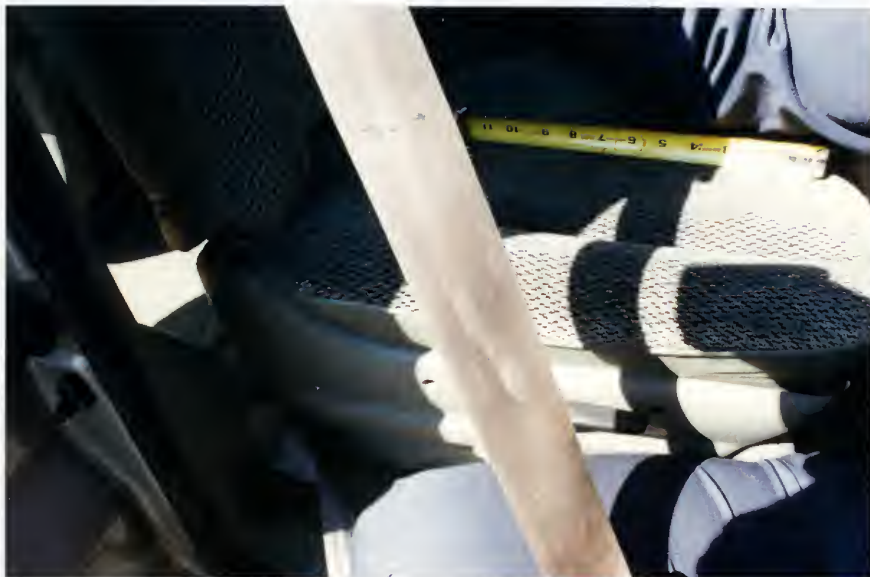
91. View of a fluid spill on the right front restraint webbing.

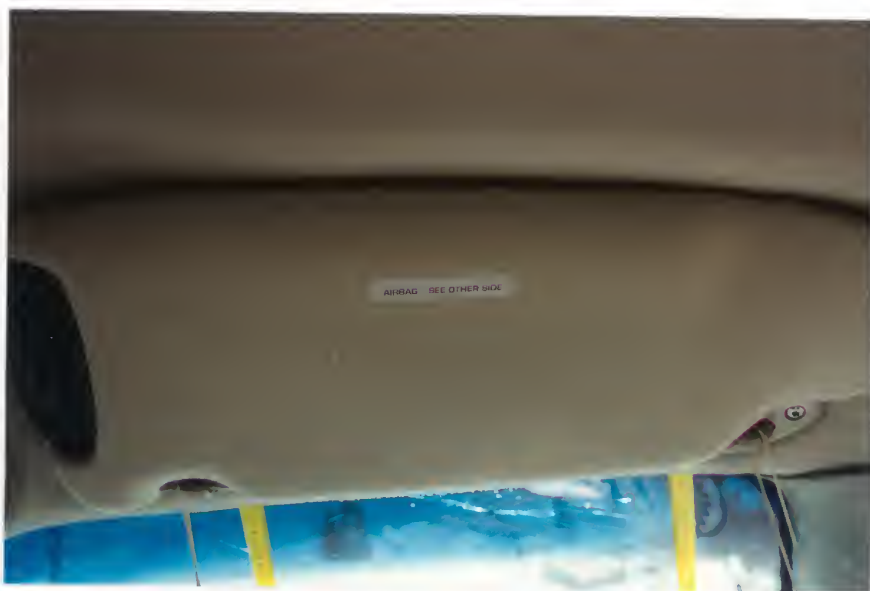
96. View of the right sun visor.

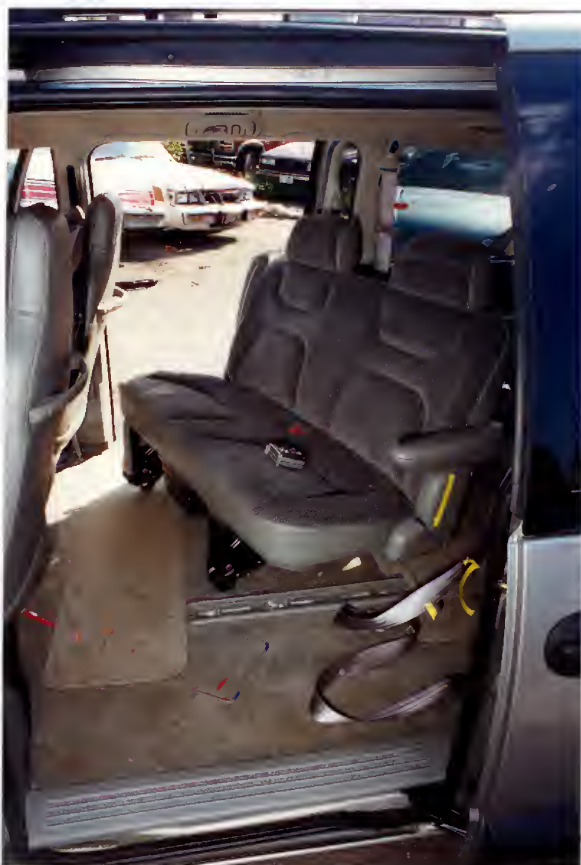
child safety seat on the seat cushion. Abrasions were noted to the shoulder belt webbing and to the plastic extrusion at the seat cushion/seat back juncture. In addition, the loading produced a D-ring transfer to the shoulder belt webbing. This evidence is documented in Photograph Nos. 97-102.

97. Left side view of the second seat of the Dodge Caravan.

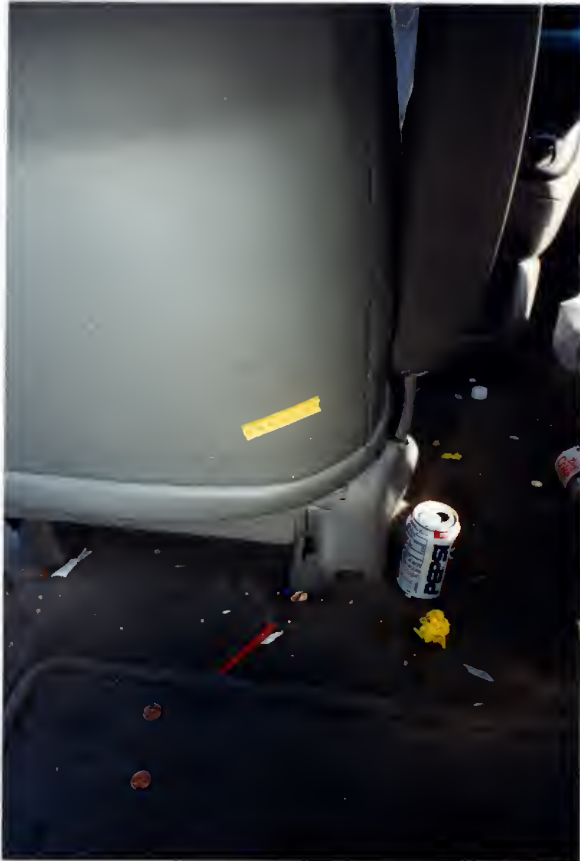
99. View of a contact to the left front seat back.

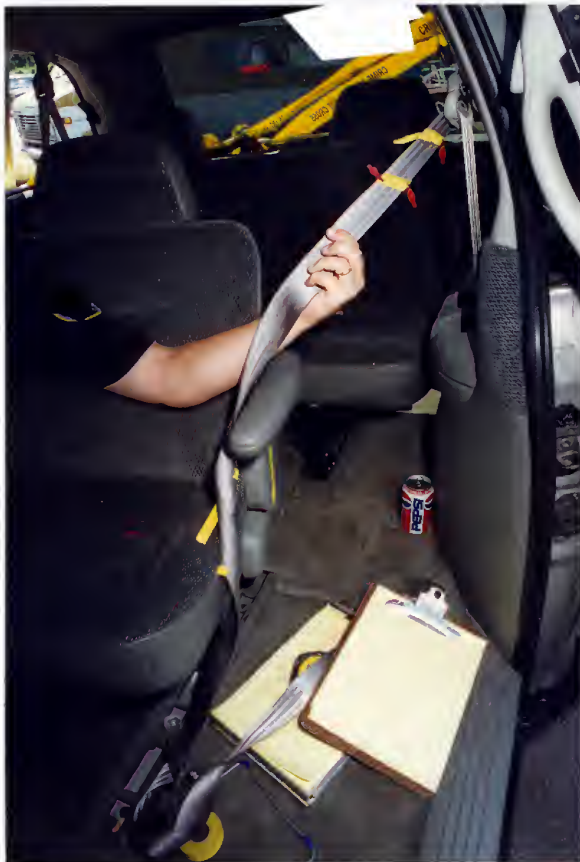
100. View of the restraint webbing for the left side second seat occupant.

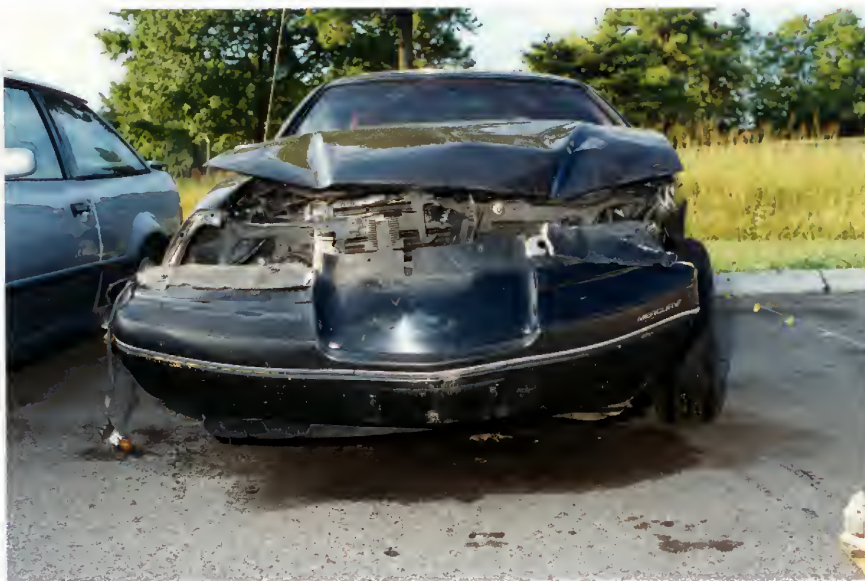
104. Front view of the 1988 Mercury Cougar.

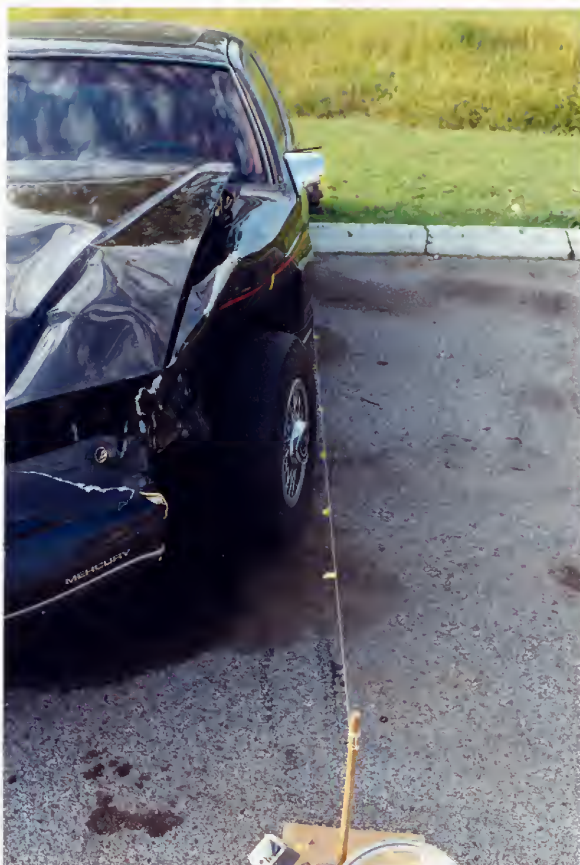
105. Left side longitudinal view of the Mercury.

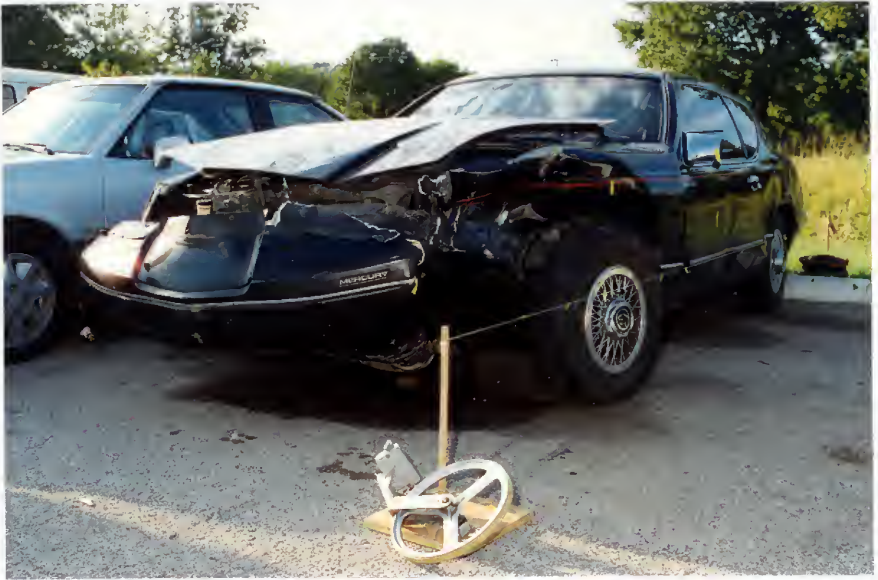
106. Left front three-quarter view of the Mercury.

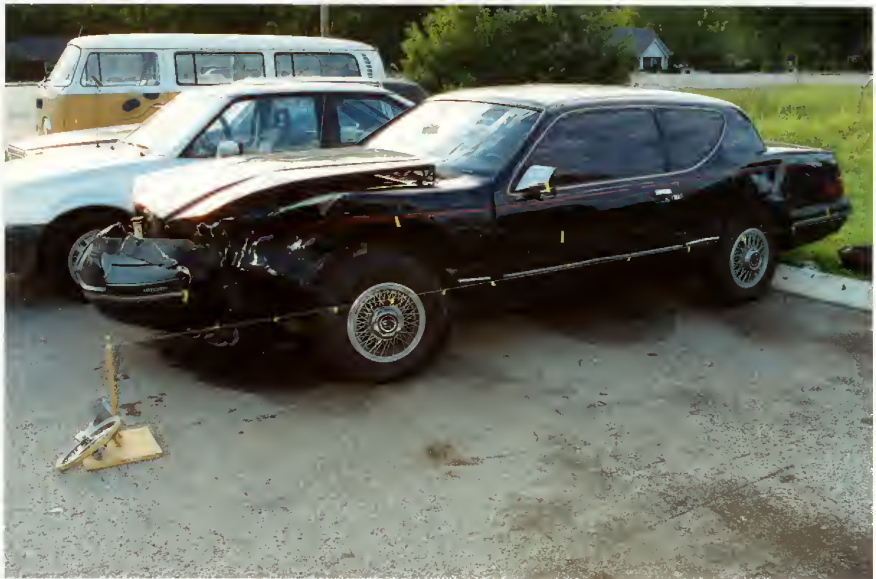
110. Left side view of the Mercury.

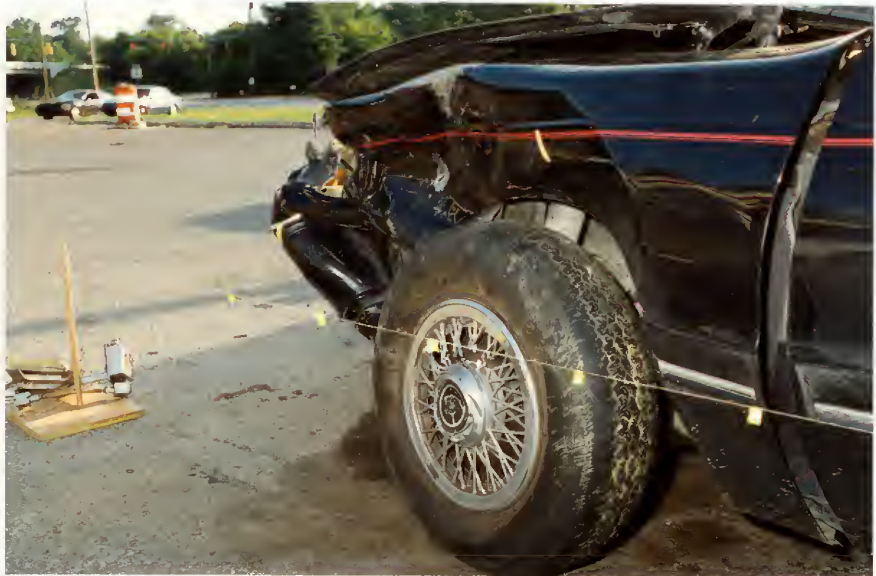
111. View of the primary contact deformation.

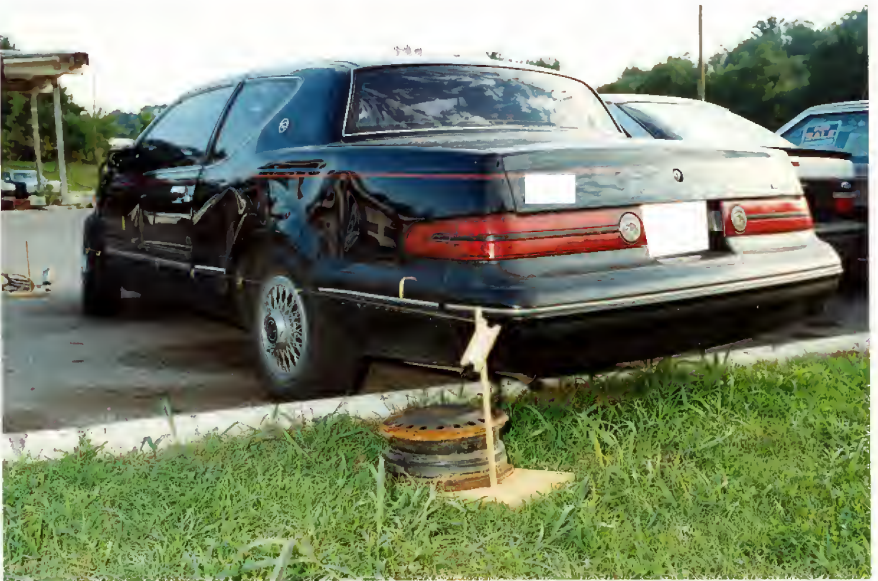
113. Left rear view of the Mercury.
